Inspection Report

123 Austin Park
Autin TX 78645

Home Critique Property Inspections LLC

PROPERTY INSPECTION REPORT

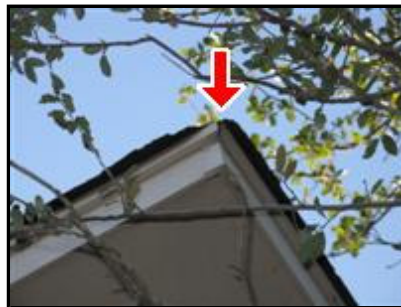
Roof edge shingles have been damaged on the front of the home in several locations, most notably on the left side of the main peak and on the "eyebrow" roof on the lower left corner. Repairs are needed to prevent water damage to wood components below.

C. Picture 5 Left front corner damage

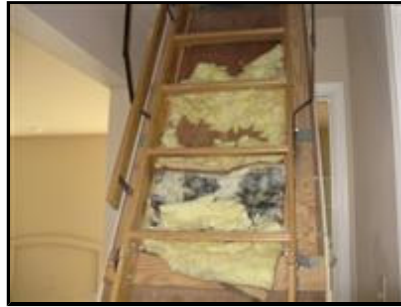
D. Picture 1

Attic access stair door needs to be properly insulated to improve energy efficiency as is now the standard.

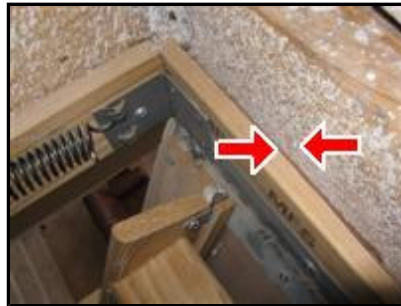
Attic access stairs are not installed according to manufacturer's instructions. It is recommended that additional appropriate fasteners be installed to ensure secure installation. (typically 16d or 1/4" lag bolts are recommended) The stairs need to be shimmed and fastened more securely to prevent catastrophic failure. Very few deck screws are installed and are in need of augmenting.

D. Picture 2 Shimming needed

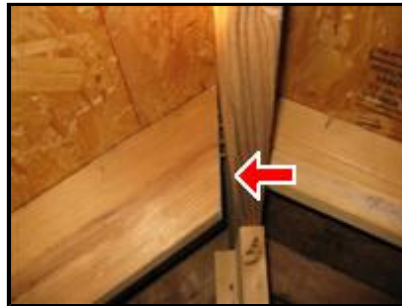
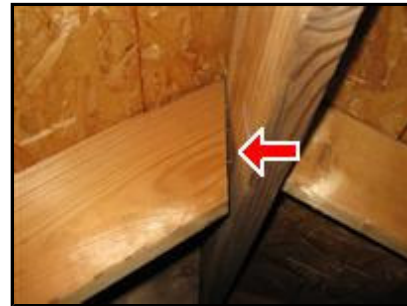
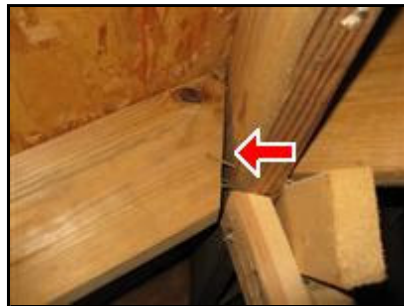
Several roof rafters have somewhat poor connections to the ridge beams that they are attached to. This was most notably seen at the left front roof peak and near the attic access opening of the home. Recommend further evaluation by reputable contractor to augment or support these connections more satisfactorily where there are gaps that have been spanned with nails.

D. Picture 4 Left front rafter gap

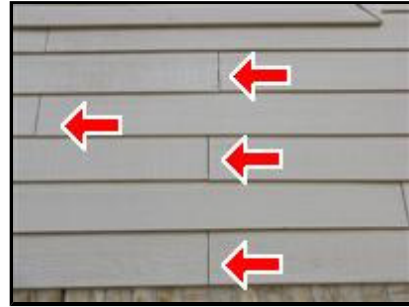
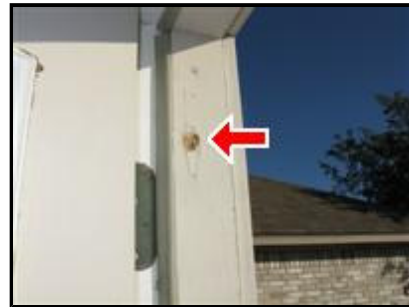
Seal all areas on exterior of home to prevent water damage to unprotected wood, most notably: pipe penetration openings, seams in trim and siding, around window frames and any bare wood.

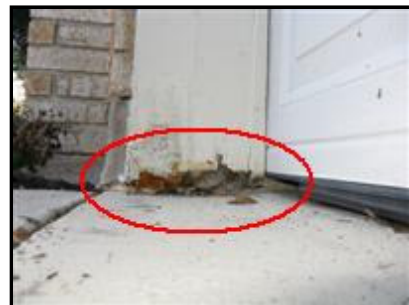
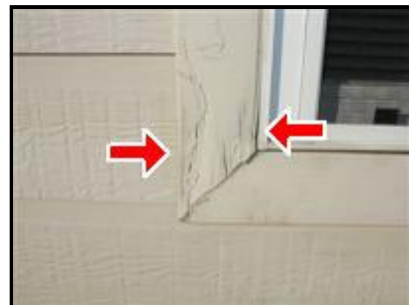
Damaged and water softened around home needs to be repaired or sealed to prevent further deterioration.

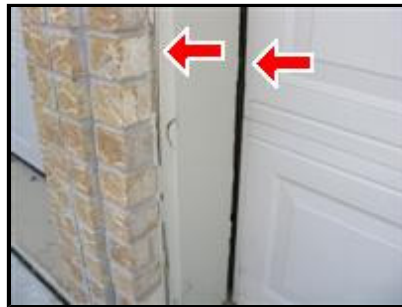
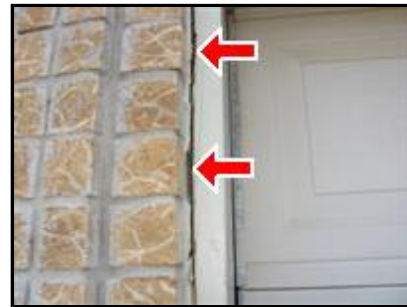
The left side garage door trim on the right door is damaged where it has been impacted and pulled slightly away from the brickwork. The trim along the back has broken off and leaves a gap between the door and trimwork. Recommend repair or at least sealing to prevent water damage.

E. Picture 20 Damage to garage door trim

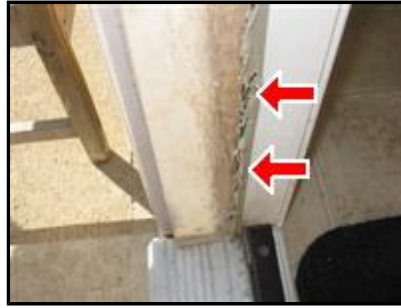
Back door has damaged weather-stripping due to pet activity, but the door does not

G. Picture 1 Damaged weatherstripping

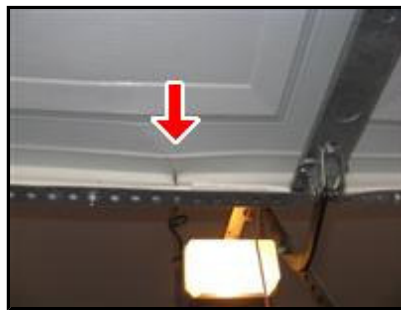
G. Picture 2

Garage doors have had previous damage to the top edge and have been repaired and strengthened to maintain satisfactory operation.

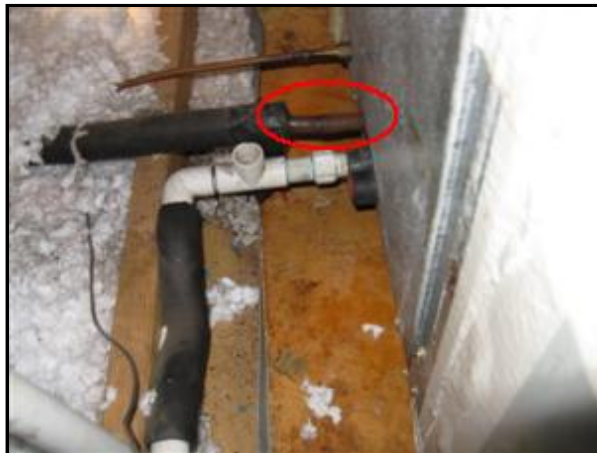
The a/c drainpan for the upstairs has had considerable previous moisture inside, most likely from condensation that dripped off the exposed cold freon line on the back side. Recommend insulating the exposed section and cleaning rust from pan to ensure it is not rusted through.

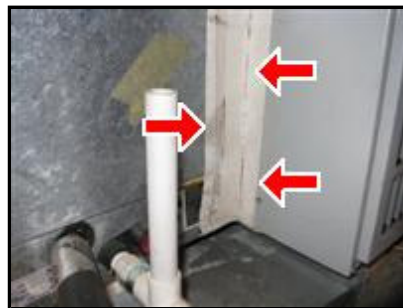
The downstairs a/c housing has minor air leakage at the joint between the a/c and furnace housings that needs to be resealed.

C. Picture 1 Air leaks

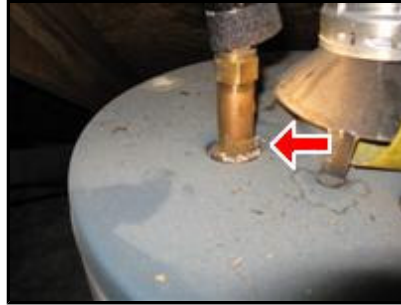
One of the water heaters has minor corrosion at the water connections that needs to be cleaned to prevent deterioration and eventual leakage.

C. Picture 1 Minor corrosion
