Inspection Report

123 Austin Park
Autin TX 78645

Home Critique Property Inspections LLC

PROPERTY INSPECTION REPORT

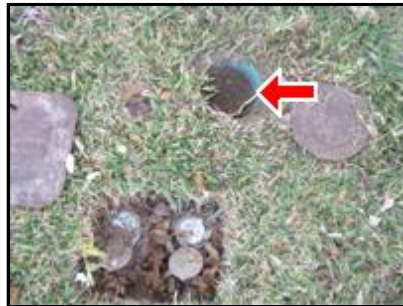
Shutoff valve buried
